# Manhole Inspection Summary

Manhole # S51AA\_027MH

Insp Date: **7/17/08 1:40 PM**

**Location** Address: **638 n streeper st**

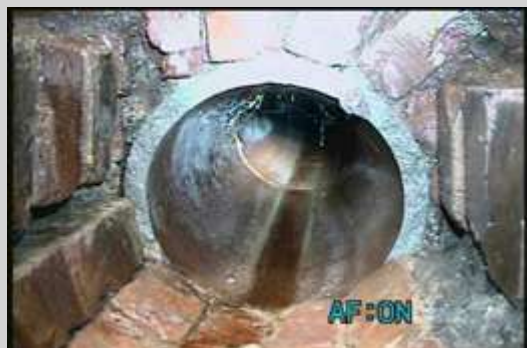
12 O'Clock Outflow

8 in. Circular Gravity Sewer  
Pipe Out @ 12 O'Clock

Pipe Height: 0 (in.) Direct

Pipe Material: **Clay** ☐ Pipe Lined

Invert Depth: **8.75** (ft.) Flow Characteristics: **Fast**

Deposits: ☒ None ☐ Mud ☐ Sludge ☐ Debris ☐ Grease

Infiltration: **None** Pipe Seal Cond: **Unknown**

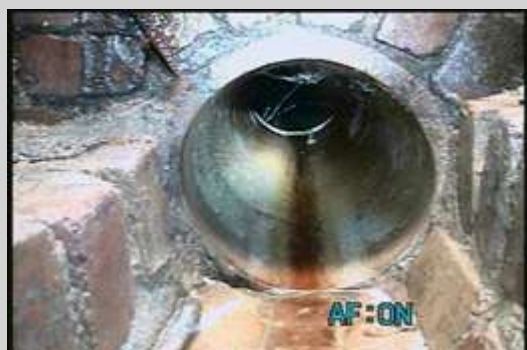
3 O'Clock Inflow

8 in. Circular Gravity Sewer  
Pipe In @ 3 O'Clock

Pipe Material: **Clay** ☐ Pipe Lined

Invert Depth: **8.38** (ft.) Flow Characteristics: **Slow**

Deposits: ☒ None ☐ Mud ☐ Sludge ☐ Debris ☐ Grease

Infiltration: **None** Pipe Seal Cond: **Unknown**

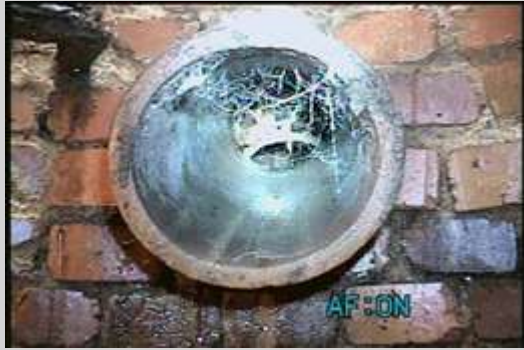
7 O'Clock Inflow

8 in. Circular Gravity Sewer

Pipe In @ 7 O'Clock

Pipe Material: **Clay** ☐ Pipe Lined

Invert Depth: **5.81** (ft.) Flow Characteristics: **None**

Infiltration: **None**

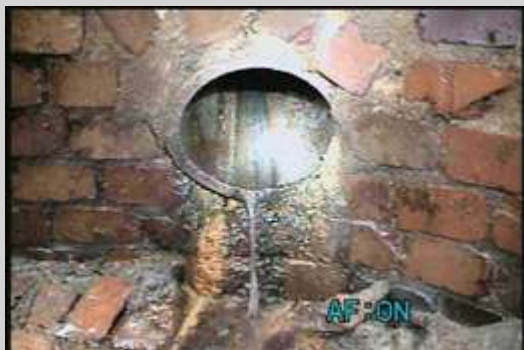
9 O'Clock Inflow

6 in. Circular Gravity Sewer

Pipe In @ 9 O'Clock

Pipe Material: **Clay** ☐ Pipe Lined

Infiltration: **None**
